Electricity and Lighting Audits at The Bono Pekanbaru Hotel

Muhammad Fiqri Ramadhan[1](✉), Zulfatri Aini[1]

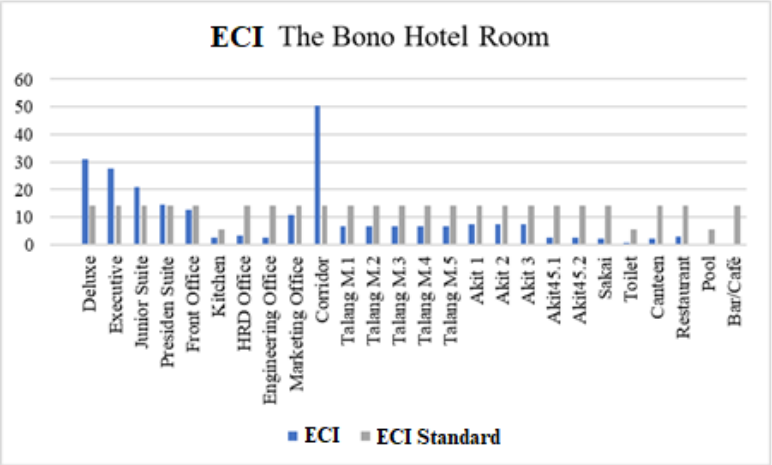
Fig. 2. Graph of room energy consumption intensity at the Bono Pekanbaru Hotel

Based on the results of the energy consumption intensity (ECI) calculations carried out, there are several rooms that fall into the category of efficient and wasteful use of electricity. The ECI calculation results obtained show that the lodging room exceeds the existing ECI standard, which causes it to enter the category of waste electrical energy.

Based on Figure 2, the graph shows that the deluxe, executive, junior suite, presidential suite, and corridor rooms experienced an increase in the energy consumption intensity (ECI) value, which exceeded the set ECI standard.

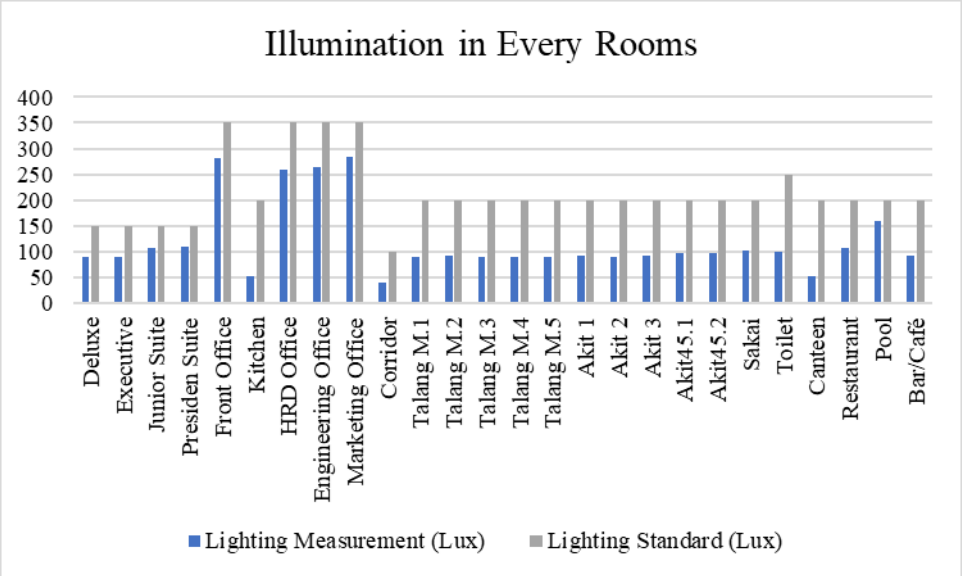
Fig. 3. Bono hotel room lighting comparison graph

Based on an audit that has been carried out on the lighting system at the Bono Pekanbaru Hotel, measurement results have been obtained, which can be seen in Table 8. The lighting system in the hotel rooms does not meet SNI 03-6197-2000 standards [24]. There are still many rooms that look dark even though the lights are on. This is because the rooms in the hotel still use non-LED lamps, which are not environmentally friendly because the power of the lamps is small and not in accordance with the room they are illuminating. So, it is necessary to replace and install energy-saving lamps and good lighting using LED lights. It can be seen in Table 11. Recommendations for replacing lamps in the lighting system at the Bono Hotel Pekanbaru.

Based on Figure 3, Shows a comparison graph of the lighting system with the SNI 03-6197-2000 standard found at The Bono Hotel. The graph shows a significant difference in that the light intensity in each room still does not meet the existing standards, so it is necessary to replace the lights.

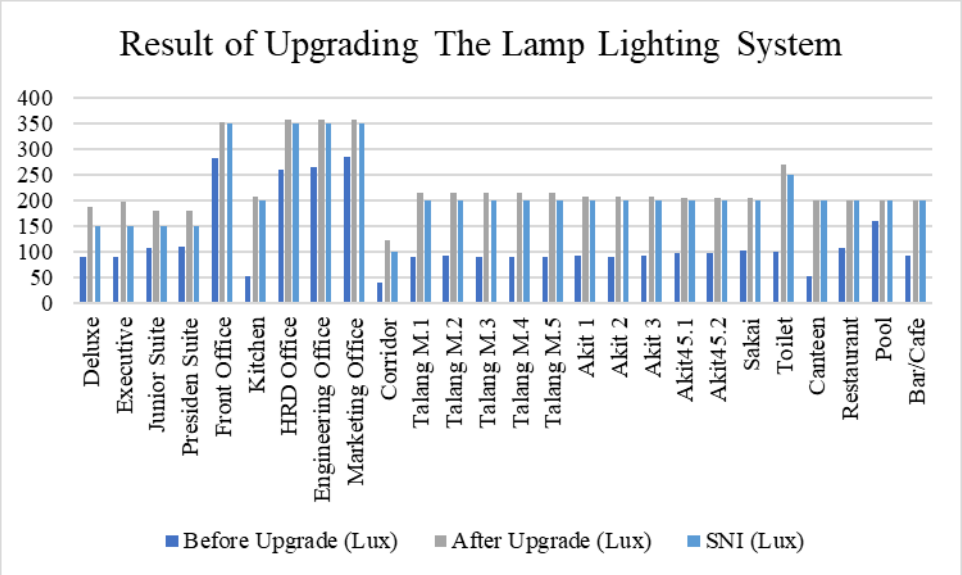
Fig. 4. Comparison graph of lighting before and after lamp replacement

After replacing the light bulbs in the lighting system found in the inn rooms, the graph in Figure 4. Shows the increase in light intensity in the deluxe, executive, junior suite, and president suite rooms. The increase in light intensity has met the minimum standard of lux that has been set. Whereas in the rooms at The Bono Pekanbaru Hotel, after the replacement of the lights, there was an increase in the value of lighting intensity (lux), which has met the SNI 03-6197-2000 standard of lighting intensity in each room.

After the results were obtained in the form of recommendations in the form of changing the type and power of lamps in the lighting system of The Bono Hotel Pekanbaru, the results were obtained in the form of an appropriate increase in light intensity and had met the lighting standards of Indonesian National Standard (SNI) 03-6197-2000 [24].
